*Report to Delca Systems on the Results of a Geotechnical
Investigation for the Proposed New Municipality Clinic in
Dannhauser, KwaZulu-Natal*

Reference: 128-11.R01

Dated: 13 May 2011

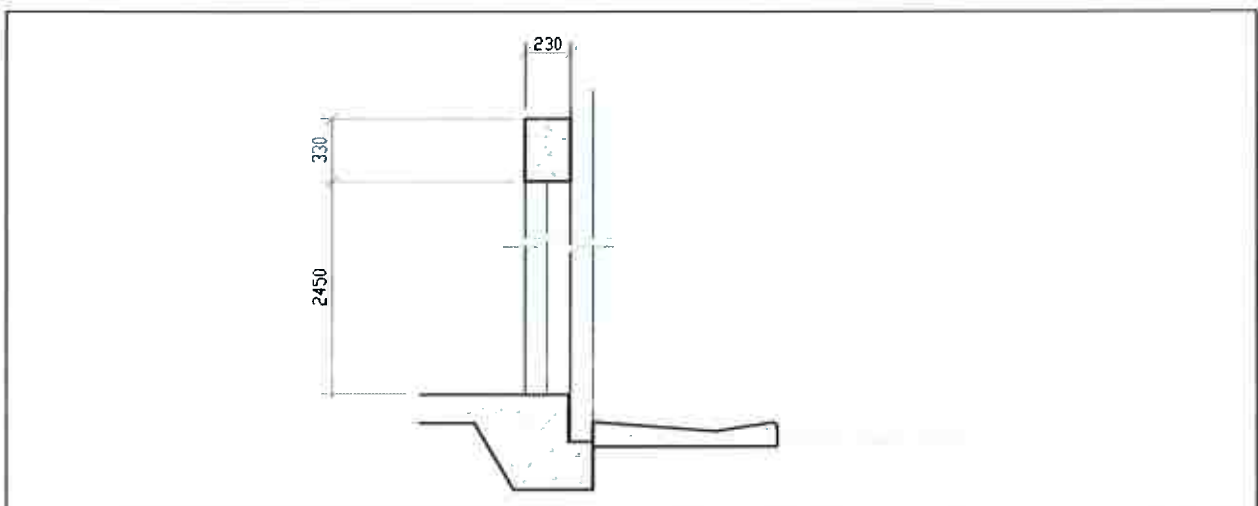
There is also no indication whether the beam spans across the movement joints, but based on our observations on site, there appears to be no joints in the beam.

Figure 2 - Ring beam detail given for module 16 (Add administration). This detail is not shown on the drawings for other buildings.

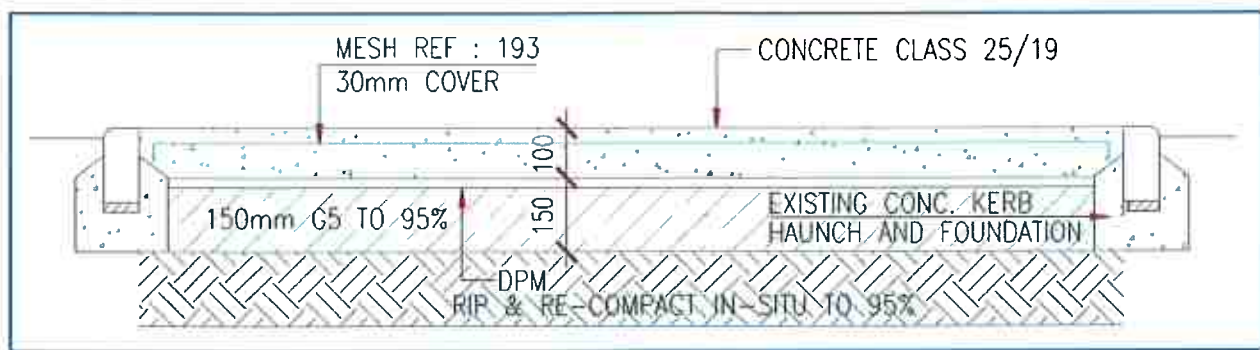
Figure 5 - Section through walkways using kerbs. Drawing implies that the kerbs existed?

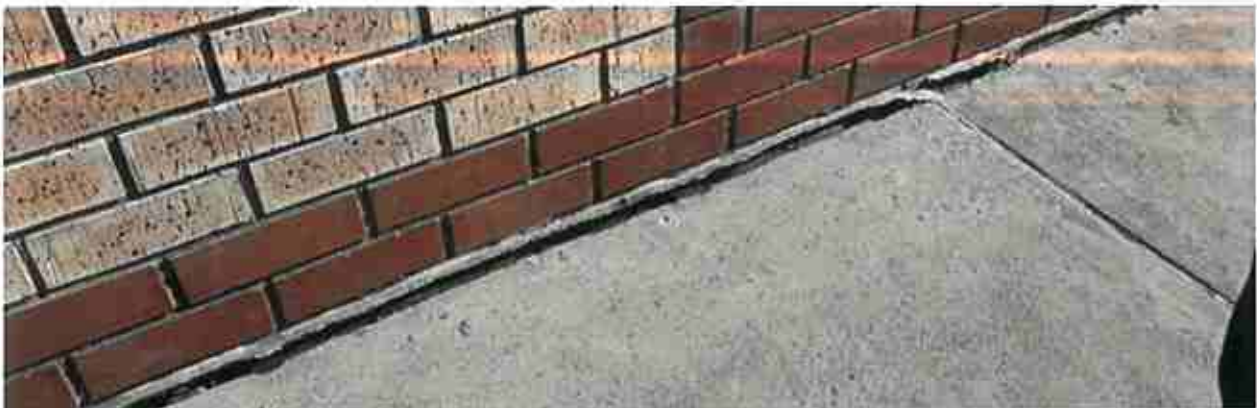
This is a serious problem as the purpose of the aprons is to provide an impermeable barrier. Currently, rather than preventing water getting out or into founding stratum, most are permeable and the water running down walls will be caught and channelled into the soil.

Figure 6 - Gap of over 30 mm between the apron and wall and drop of 25mm in the apron

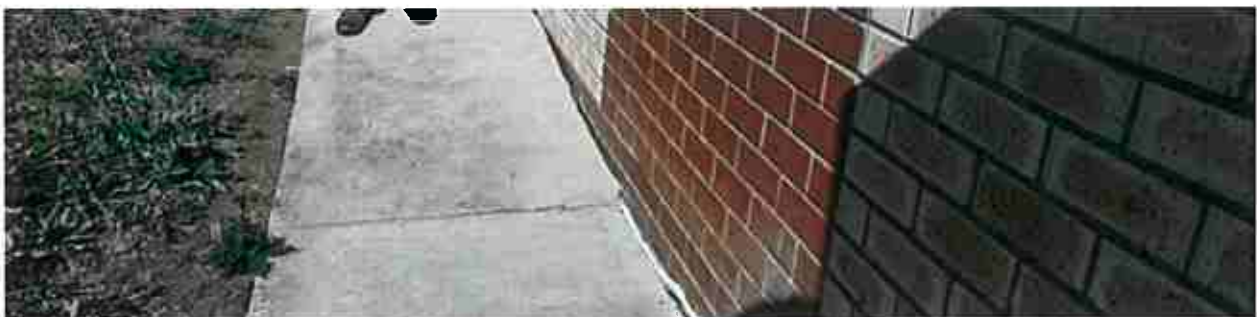
Figure 7 - Apron east of the main complex showing the embankment falling towards the apron without proper drainage. Also note the gap between the wall and the apron in which rainwater that is driven onto the walls infiltrates the substrate

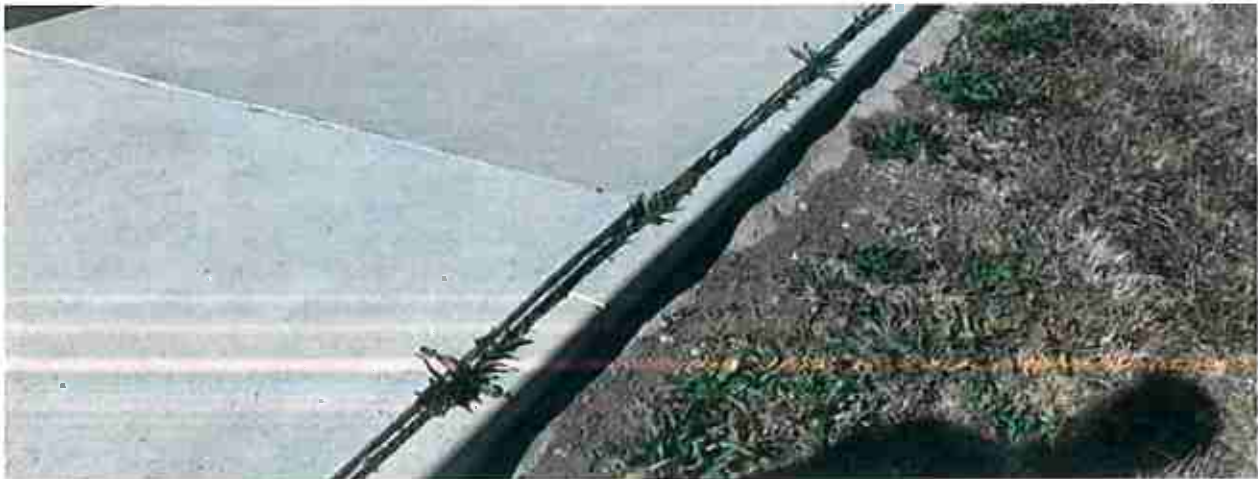
There is widespread damage to the walkways with obvious vertical and horizontal movement as can be seen in figure 9. There are also other where the panels are large and have cracked such as adjacent the domestic building and south of the main complex.

Figure 8 - Typical walkway showing vertical movement between panels and also the kerbs

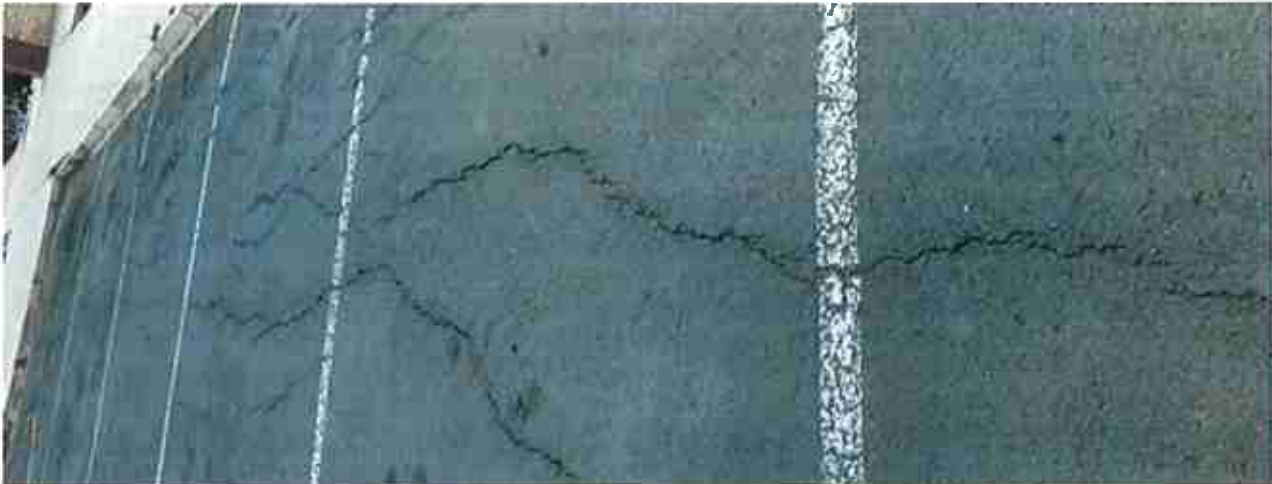
The roads are performing relatively well relative to a number of the other elements on this project as the specification is satisfactory and they seem to have been built to that detail. There has however been some movement and there are areas of surface cracking as indicated below in figure 10.

Figure 9 - An example of some of the more severe cracks in the tarred road/ parking surfaces

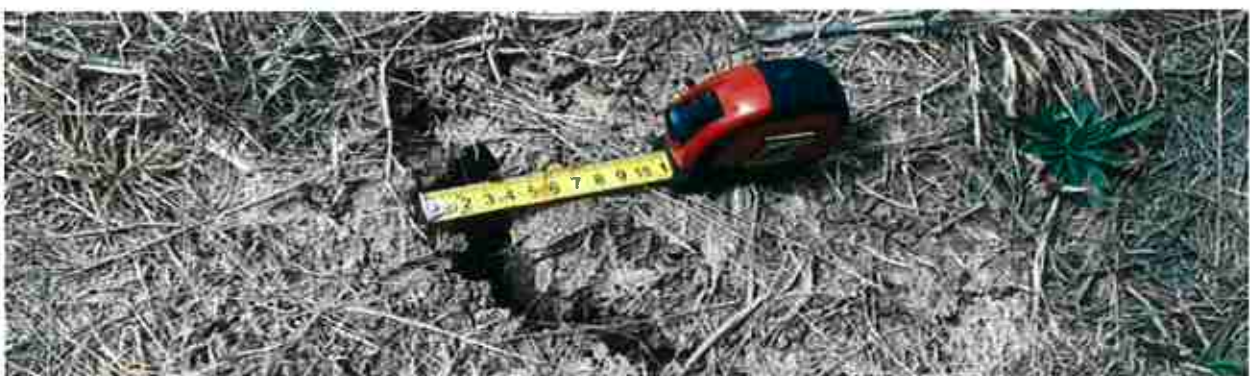
The damaged buildings have a number of grassed areas in close to the building perimeter. A number of these have very severe desiccation cracks indicating the presence of highly active clay. The attached plan indicates these areas which are not properly drained. We would at least expect an open drain which takes the water to a piped system. The areas of grass within 5m of a structure need to be sealed to prevent the ingress and loss of water. Refer to the attached plan showing the area that we propose upgrading.

Figure 10 - Desiccation cracking in soil adjacent to the additional administration building There are similar cracks on the east and south sides of the main buildings

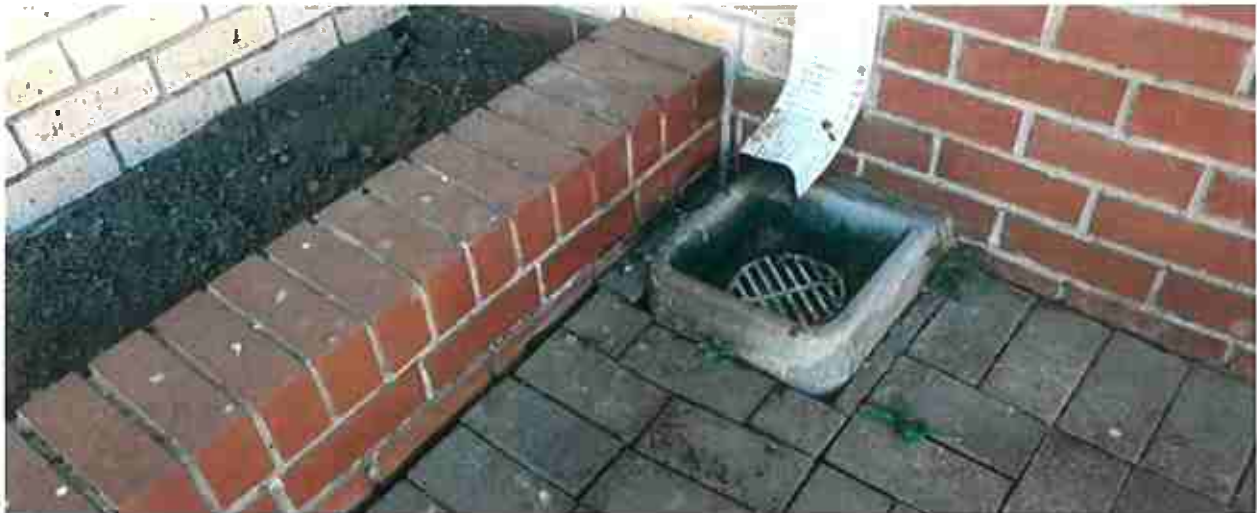
Figure 11 - Courtyard flower box against the building and drain which is not working correctly

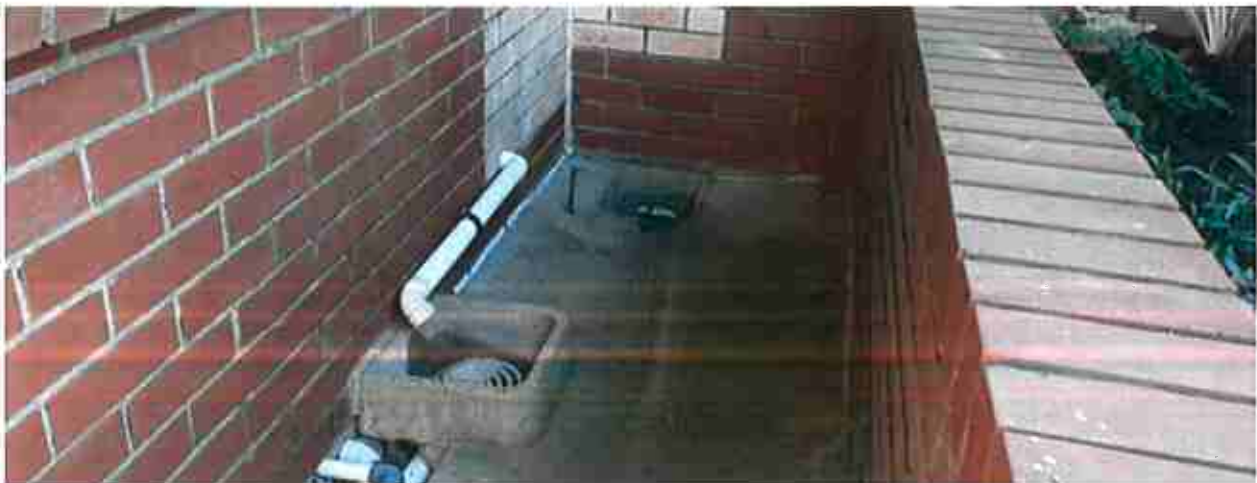
- Other services: - At least in one instance as shown in figure 13, services penetrate the building below the level of the paving and a trench has been built to accommodate this. It is not drained and will seep into the soil below

Figure 12 - Courtyard drainage showing drainage and in lower left services which penetrate the surfacing

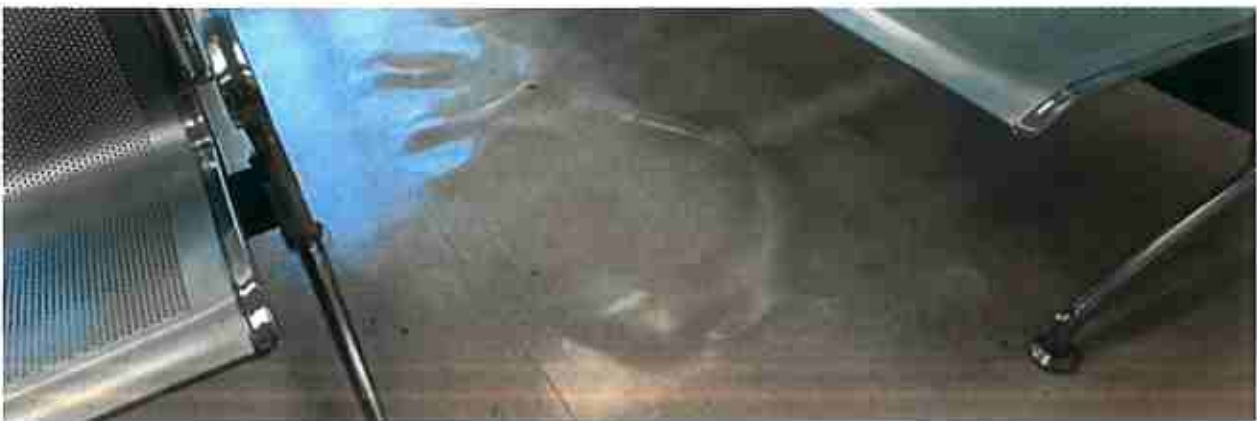
Figure 13 - Damage to the floor covering in a number of wards

- Remove the floor covering over the whole extent of the room
- Arrange for an inspection by the engineer
- Repair and seal any cracks
- Allow the floor to dry adequately by measuring the moisture content
- Replace the floor covering with new material and to the manufacturers specification
