*Report to Delca Systems on the Results of a Geotechnical
Investigation for the Proposed New Municipality Clinic in
Dannhauser, KwaZulu-Natal*

Reference: 128-11.R01

Dated: 13 May 2011

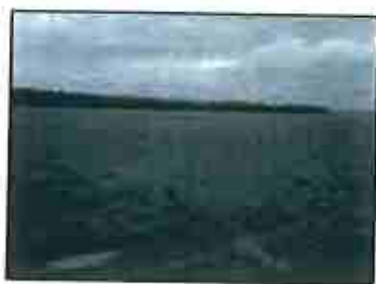
Plates 1 and 2: General views towards the north across the study area

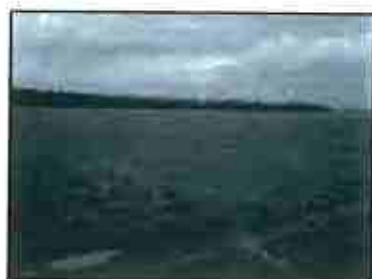
Plates 1 and 2: General views towards the north across the study area

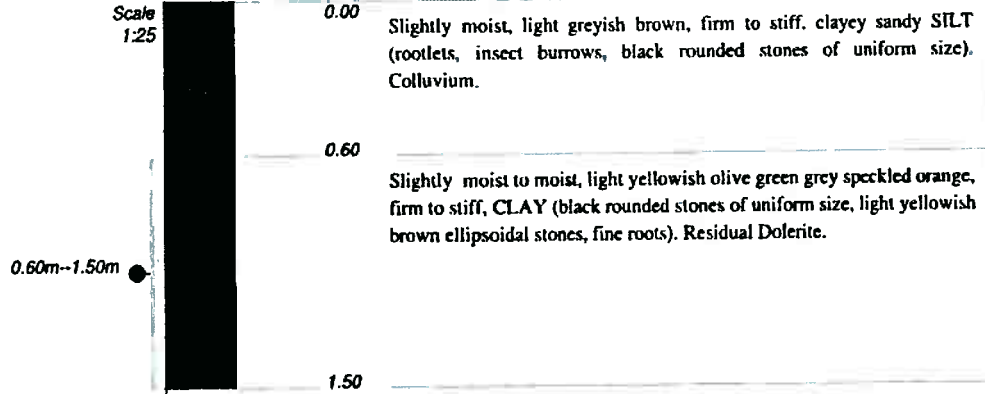
HOLE No: IP1
Sheet 1 of 1

- 1) No ground water seepage observed.
- 2) Sample taken at:
SI 0,60m--1,50m (Ind)
- 3) Area scattered with few dolerite cobbles and boulders.
- 4) Final depth at 1,5m.

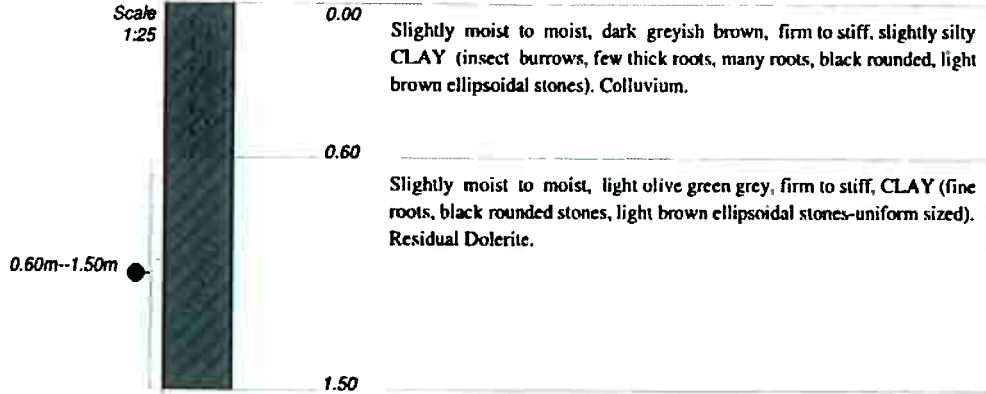
HOLE No: IP2
 Sheet 1 of 1

- 1) No ground water seepage observed.
- 2) Sample taken at:
 S1 0m--0,60m (Ind)
 S2 0,60m--1,50m (Ind)
- 3) Area scattered with few dolerite cobbles and boulders.
- 4) Final depth at 1,5m.

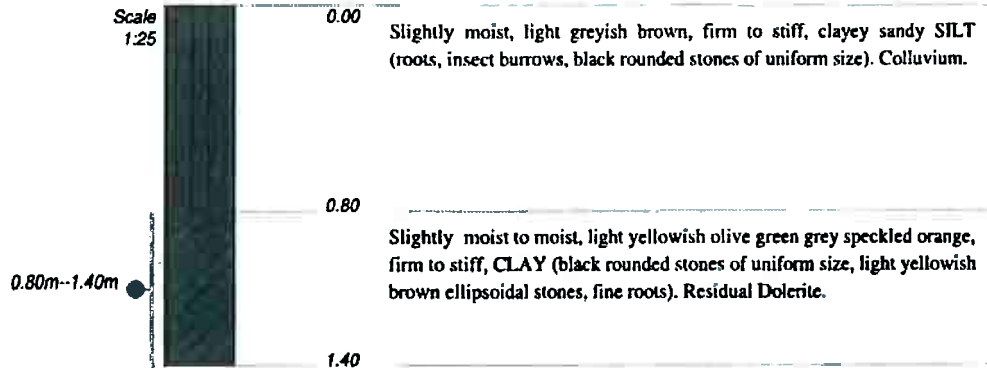
HOLE No: IP3
Sheet 1 of 1

- 1) No ground water seepage observed.
- 2) Sample taken at:
S1 0,80m--1,40m (Ind)
- 3) Numerous termite mounds in area around inspection pit3.
- 4) Final depth at 1,40m.

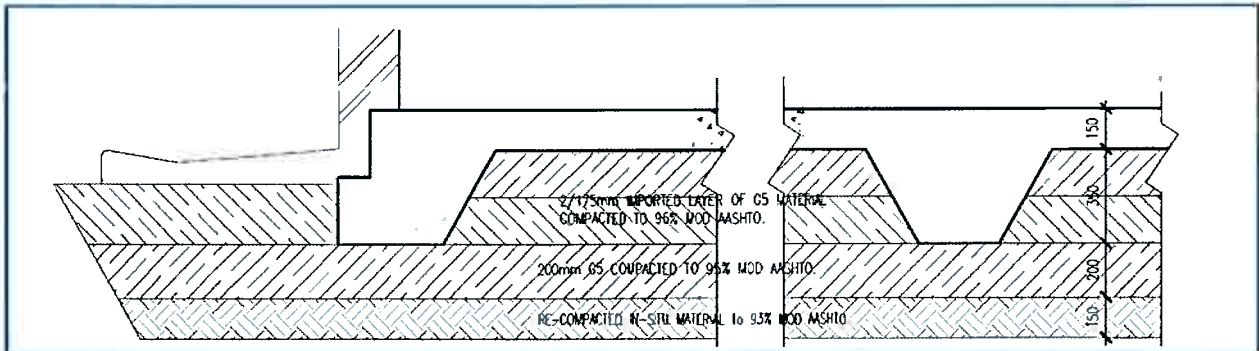
Figure 1 - Typical layerworks under floors

A series of platforms were formed in the in-situ material on which the buildings were constructed. The drawings indicate that the in-situ material was to be compacted to 93% MOD AASHTO and that there are then 3 layers of imported material placed on this, i.e. a 200mm layer of G5 to compacted 95% and two 175mm layers of G5 compacted to 96% MOD AASHTO. The beams of the rafts were excavated through these top two layers and are supported on the lower layer of G5

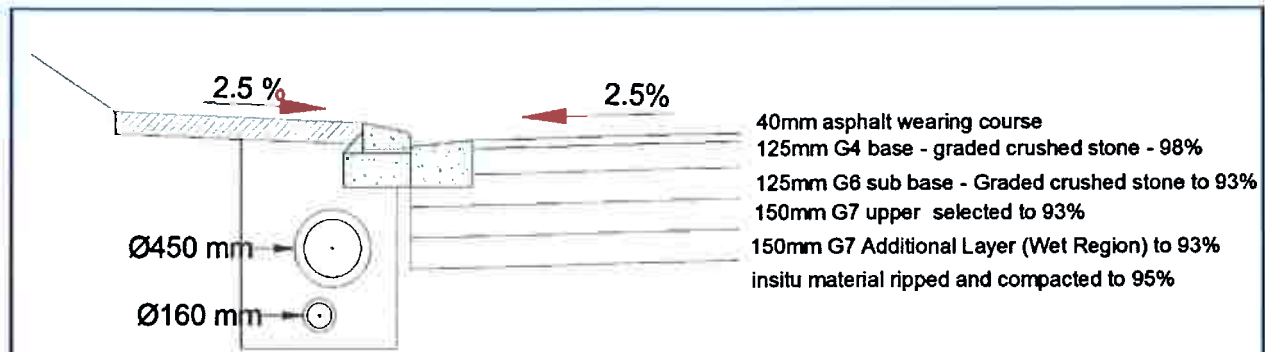
Figure 3 - Typical Road cross section showing kerbs and service positions

The road sidewalks are indicated in figure 3. The width varies depending on location and are constructed in concrete. The drawings call for reinforcing in the concrete, but we could not confirm that this has been used. The drawings do not give the specification to be used for the material under the sidewalks.

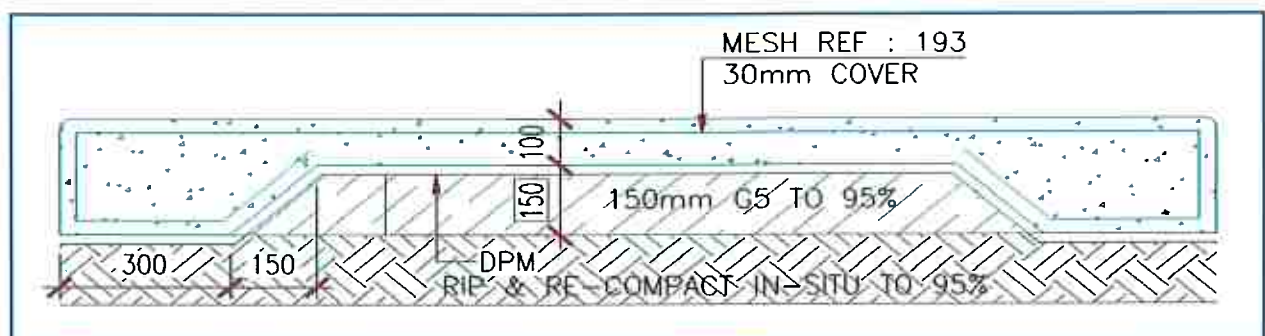
Figure 4 - Section through walkways without kerbs

There are a number of external pedestrian walkways. The drawings indicate a reinforced concrete structure with downstand edges. There are no details of the joints between the panels.

It appears that there are some walkways where kerbs existed, and the concrete is placed between these using a similar specification

It is proposed that the walkways are lifted and that a similar detail to that used for the aprons be used to get the founding material down to a zone with less potential moisture change and movement. The detail given in figure 4 should be used.
